CONDITION REPORT # B2913

"MASALA"

In accordance with instructions from Mr Grant DaCosta, an inspection was carried out on a 12.65 metre Radford designed cruising cutter known as *"Masala"*. The purpose of the inspection was to prepare a condition report for insurance purposes. The inspection was conducted whilst the vessel was in the water and on the hard stand at East Coast Marina, Manly on the 19th of March 2009. For the duration of our inspection the weather was fine and warm and did not impede any aspect of our work.

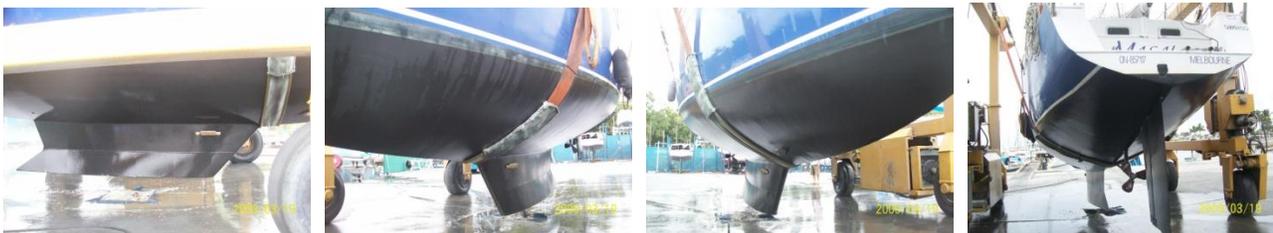
The vessel was inspected out of the water at which time we carried out a visual inspection. The bottom of the vessel is in above average condition for its age.

We found no indication of corrosion, leaching or adhesion problems. The current owner advised that approximately 12 months ago he has applied 20 litres of Jotan Sea Guardian antifouling. This remains in top condition.

There is no evidence of collision or grounding.

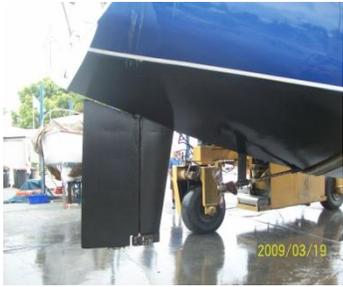
The hull is fitted with two large block anodes on the hull, adjacent the aft end of the keel and the keel has two large rectangular block anodes fitted forward. A propeller shaft anode and a propeller hub anode are also fitted. All anodes are exhibiting wear but remain in serviceable condition.

There is no indication of stressing or movement at the hull/keel intersection or at the intersection of the hull and full length rudder skeg. The skeg carries the bottom rudder gudgeon and this was checked and found to be secure.

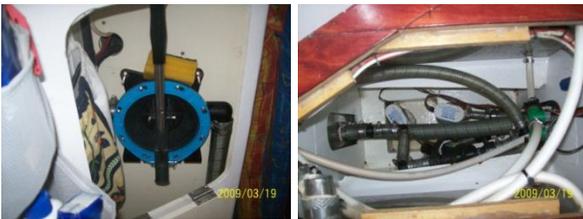
Three, 12 volt, electric submersible bilge pumps are fitted. One is located beneath the forward cabin sole and the remaining two are beneath the saloon cabin sole. Two of the pumps are fitted with float switches and the third has a manual switch. All were tested and working. A Manual bilge pump is also fitted in the head and is functional.

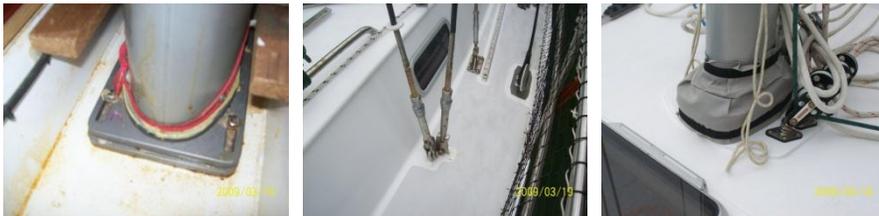
The vessel is rigged as a masthead cutter with an aluminium section mast and boom. The mast is keel stepped. The base was inspected and found to be corrosion free. The mast has two sets of slightly swept spreaders with cap shrouds, dis-continuous intermediates and aft lower shrouds. The permanent forestay is fitted with a Reefit roller furling system. A fixed backstay is fitted. All rigging is 1 x 19, Dyform, stainless steel and appears in good condition. There is no indication of stressing or movement at the mast base or the chainplates, either internally or externally. All running rigging is appropriately sized and remains in good condition.

The picture above left shows an orange substance in the mast base well. This is fish oil residue, not rust. Fish oil is occasionally put in the well as a preventative measure, to ensure that inaccessible parts of the mast base remain corrosion free.
